PCB CONTAMINATION STUDY

THOMPSON FACILITY St. Louis, Missouri

ENVIRONMENTAL SCIENCE & ENGINEERING, INC. St. Louis, Missouri

ESE No. 590-1157-0100

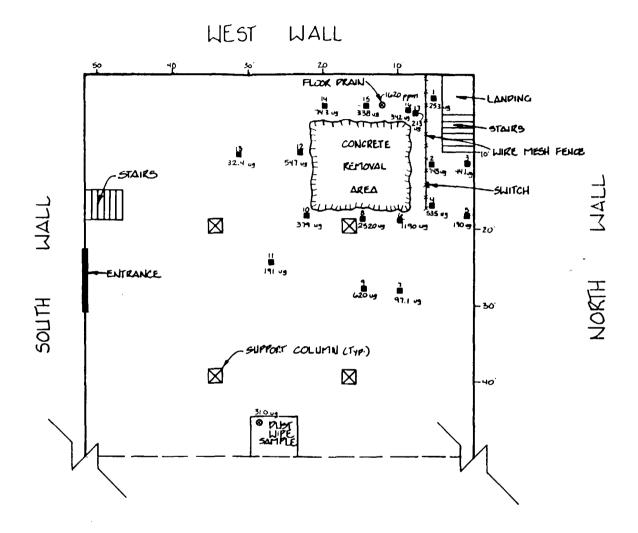
3-1

As can be seen from this list and Figure 3-1, the concentration of PCBs drop as you move outward from the concrete removal area (former transformer area). It is also apparent that all areas tested exceed the cleanup guideline of 10 ug/100 cm² (see Section 3-4).

A wipe sample of (concrete) dust was collected from a concrete pad approximately 30 feet from the edge of the removal area (see Figure 3-1). The sampling procedure was identical to the methods used for the other wipe samples. The laboratory results indicated 31.0 ug/100 cm² in the sample area. The above results and the presence of white dust (presumably concrete) in the study area indicates extensive cleanup will be required.
